Success Story

Industry: Food and Beverage

Application: Milk Processing Plant

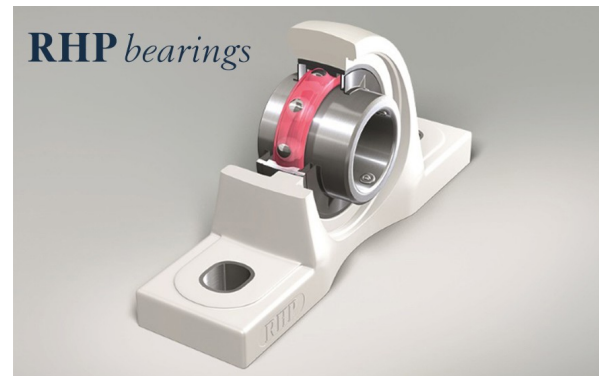
↑ Life-Lube® housing with Molded-Oil bearing insert

- PBT thermoplastic resin housing
- Molded-Oil inserts (with solid lubricant)
- Martensitic stainless steel
- Nitrile rubber seals
- Available in Pillow Block, 2 and 4 bolt flanges and take-up unit housings
- Bore size 20mm – 40mm
- Corrosion resistance
- Paint free housings, preventing chipping & flaking
- Resistant to contamination increasing operating life
- Ideal for operations where process fluid is unavoidable
- No need for re-lubrication
